Pond System Management Plan

Winslow Farm Community Association Perry Township, Monroe County, Indiana

September 2018

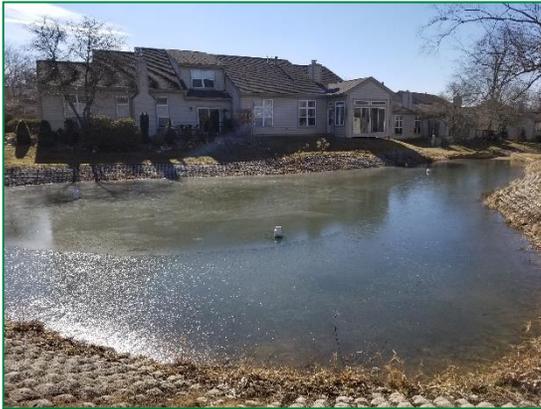
Pond 1 is the upper-most waterbody in the system. The pond is located southwest of the East Winslow Farm Drive and South Highland Avenue intersection. The pond is approximately 0.11 acre with an average depth of 2 feet. Three aerators are installed in the pond to create adequate mixing for improved dissolved oxygen levels.

Water inputs into Pond 1 include runoff from South Highland Avenue, stormwater pipes from surrounding residences, and through a water pump in Pond 7 creating a continuous loop in the pond system. A silt trap was installed at the inflow from South Highland Road in September 2017 to filter soil and rock particles from water moving into the system. Other recent work in the pond includes dredging in 2015 and a new pond liner and shoreline repair with Flexamat installation in the fall of 2016. Approximately four feet of muck was taken out of the pond at the time of dredging according to local membership and management staff.

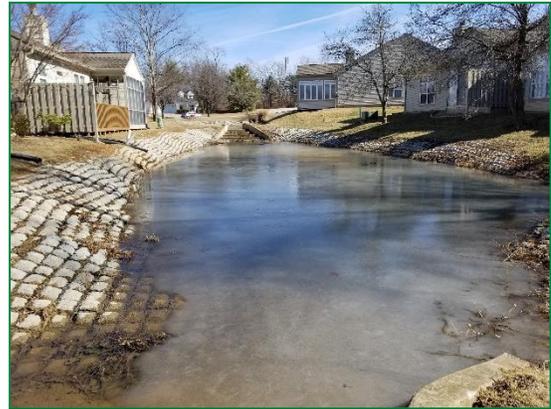
Pond 2 is located immediately west of Pond 1. The pond is approximately 0.10 acre with an average depth of 2 feet. No fountains or aerators may be found in Pond 2.

Pond 2 receives incoming water from Pond 1 through a weir. The weir was resealed on June 2017 to prevent loss of water in the pond system. Other recent work in the pond includes new pond liner and shoreline repair with Flexamat installation in the fall of 2016. Up to three feet of muck was taken out of the pond at the time of dredging according to local membership and management staff.

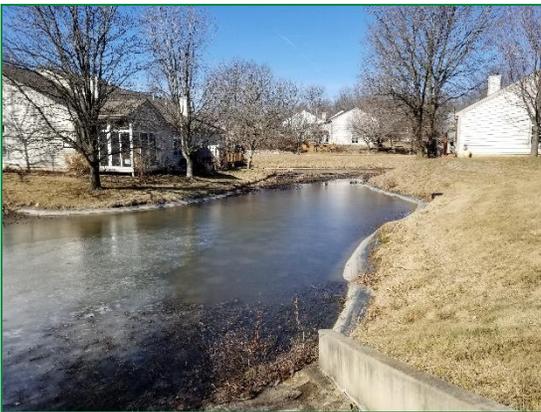
Pond 3 is located west of Pond 2, south of East Winslow Farm Drive, and north of East Moss Creek Circle. Pond 3 is the largest pond in the portion of the system within Moss Creek. The pond is 0.32 acres with an approximate average depth of 2 feet. The northern half of this pond is much shallower than the southern portion.

The pond receives water from several sources including a weir from Pond 2, a stream flowing into the pond from Winslow Woods north of the pond, a street outlet pipe, and several residential stormwater outlets. The weir between ponds 2 and 3 was resealed on June 2017 to keep water from escaping the pond system and creating erosion underneath the weir itself.

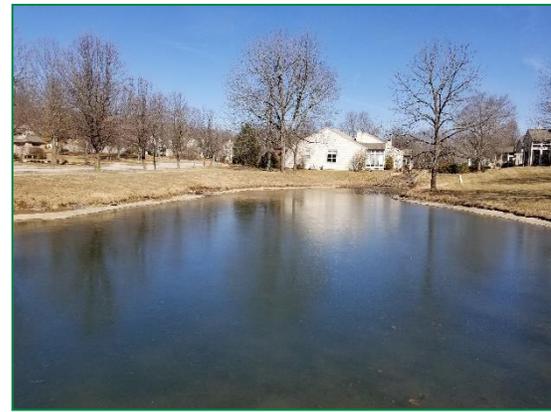
Pond 4 is located east of the intersection of East Winslow Farm Drive and East Moss Creek Circle. The pond is approximately 0.27 acres with an average depth of 2 feet. The pond receives water from a weir connected to the southwest corner of Pond 3. Water also enters the pond through a system of underground pipes designed to collect surrounding stormwater. Two underground stormwater outlets exist in Pond 4. Surface drainage from street runoff adjacent to the pond also occurs at the southwest corner of the pond.

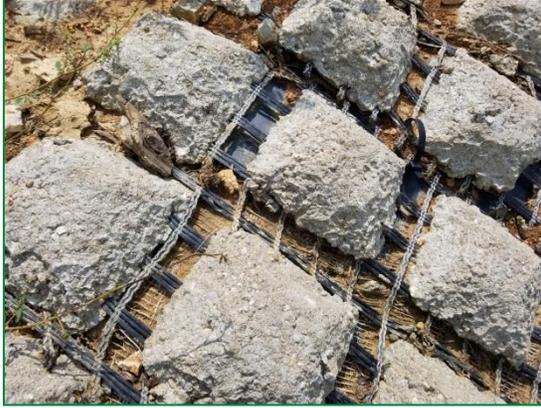
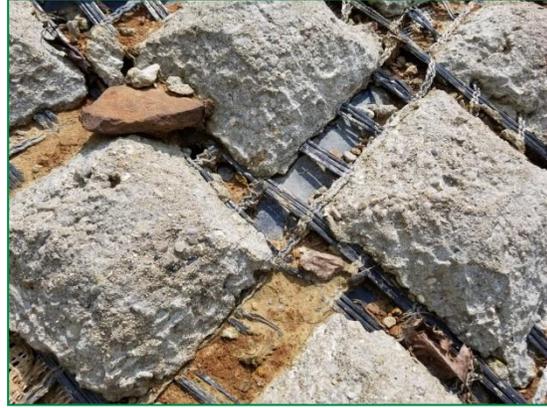
Flexamat within and surrounding Ponds 1 and 2 appears to be installed incorrectly. Vegetation is not growing through the Flexamat as planned. Davey Resource Group coordinated with D2 Land and Water as well as the Flexamat manufacture to receive further details.

The Flexamat manufacturer indicated a pond liner was installed just below the Flexamat. The pond liner was placed in this location to help promote sufficient water levels in Ponds 1 and 2. The manufacturer indicated the overall goal of the installation did not include growing vegetation through the Flexamat.

Pond Liner Below Flexamat

Whenever the Flexamat is addressed, Davey Resource Group recommends installing the pond liner several inches below the Flexamat. Native grasses require deep root systems in order to grow effectively. Place the liner approximately 6 inches below the Flexamat near the bottom of the bank. The liner should be installed approximately 18 or more inches below the Flexamat near the top of bank.

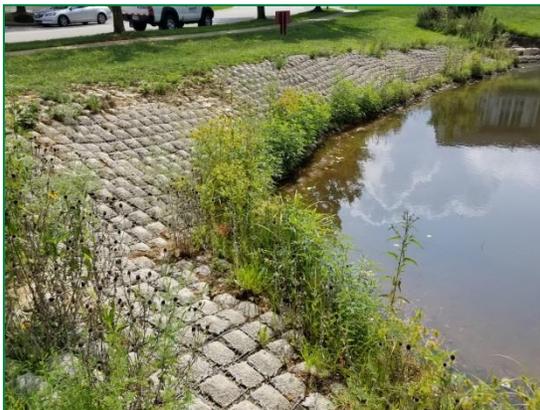
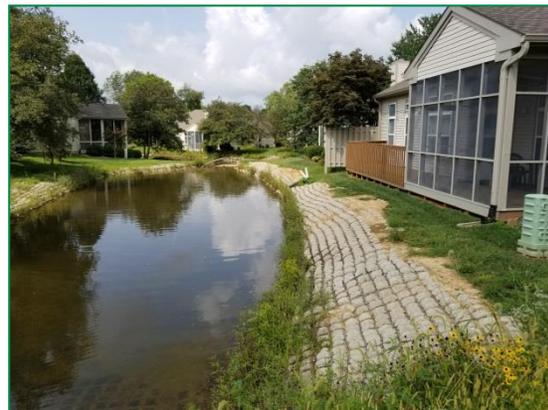
Davey Resource Group did see some evidence of seed mix germination around Ponds 1 and 2. The areas with the most success establishing vegetation are along the base of the shoreline immediately next to the water. Davey Resource Group believes this is because the soil in this location has adequate moisture immediately adjacent to the water. The thin layer of soil in the middle and top of bank will not allow for a diverse native vegetative community to establish.

Vegetation Concentrated Near Water

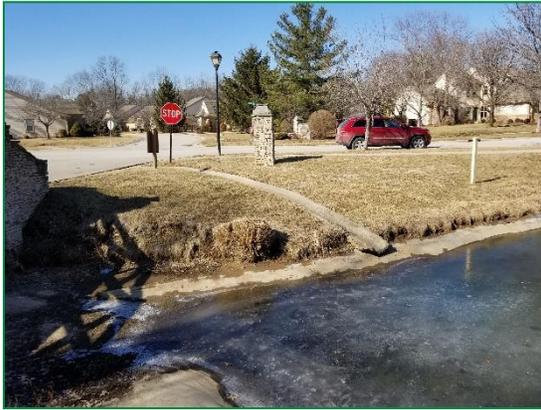
Pond 4 was roughly 6 inches below the culvert elevation. Much of the liner was exposed during the February site visit. Cracks were visible near the top of the liner exposing soil underneath. Exposed liners are likely a result of damage to the liner as well as shoreline erosion from mowing to the water's edge. Stormwater infrastructure (inlet pipes and concrete conveyances) mark the old shoreline location (photographs below).

Pond 4 Southwest Bank

Davey Resource Group recommends restoring the shoreline by placing top soil on top of exposed liners along the water's edge. Stone can be placed at the base of the shoreline to provide extra protection. Soil has fallen from the shoreline into the pond system overtime due to repeated exposure to the weight of mowing equipment. Soil for restoring the shoreline may come locally from dredged soils. Davey Resource Group recommends restoring the banks and replacing damaged liners at the same time any dredging occurs. Agency coordination should occur prior to placing any soil on the shorelines. Restoring the shoreline without replacing pond liners is recommended in Ponds 6-7. The same stone installation previously performed by Evergreen Home Improvement, LLC in Pond 7 could be used for the rest of Pond 7 and the entirety of Pond 6. Permitting agencies should be consulted before performing this activity. Davey Resource Group contacted Evergreen Home Improvements for a cost estimate to perform this work in other areas of the pond system, but the company was not forthcoming with pricing information. WFCA should contact Evergreen Home Improvement for a cost estimate to install top soil and stone along the shoreline of Ponds 6 and 7.

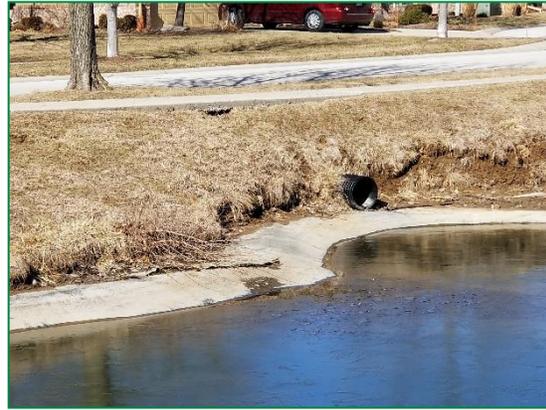
Pond 4 Northwest Bank
