Reserve Study
for
Winslow Farm Community
Association, Inc.

Reserve Study

Winslow Farm Community Association, Inc.

Account 1137 - Version 03
December 2020

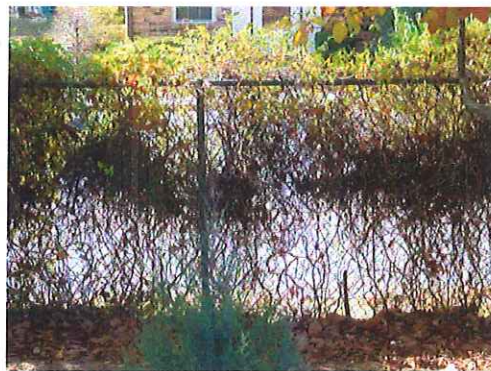
1. Henderson/Graham Chain Link Fence - 2033

There is a six foot high green chain link fence that runs east to west along Graham Drive for a length of 1,296 feet. The fence appears to be in generally good condition. Repairs and maintenance should come from the annual operating account.

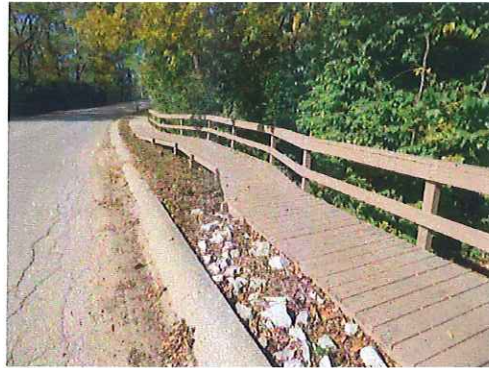
The wooden walkway is 4' wide and 210' in length with two 3' high side rails. One side rail is 210' and the second is 160'.

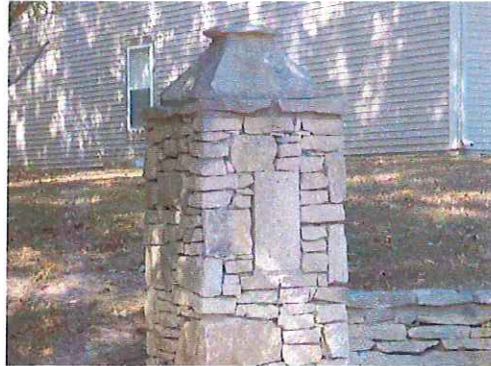
The Bent Tree Entrance is composed of a stacked stone pillar 2' x 2' x 5' high with a concrete cap. Additionally, there is a 3' high stacked stone wall that runs 150' and connects the Bent Tree Entrance Sign with the Olde Mill Entrance Sign (#24). The cost of the stone wall is split between this reserve and the Olde Mill Entrance Sign reserve #24.

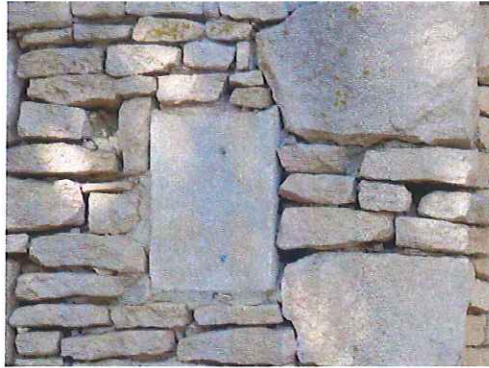
The Olde Mill Entrance is composed of a stacked stone pillar 2' x 2' x 5' high with a concrete cap. Additionally, there is a 3' high stacked stone wall that runs 85' in length.

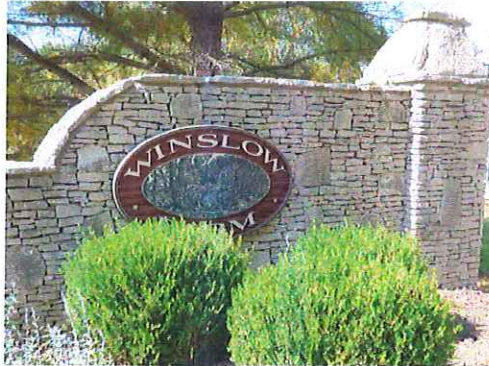
The Highland Entrance is comprised of a stacked stone pillar 2' x 2' x 6' (h) with a concrete cap. Additionally there is a stacked stone wall 15' in length with an average height of 6'. There is an engraved painted sign 5 1/2' x 3 1/2'.

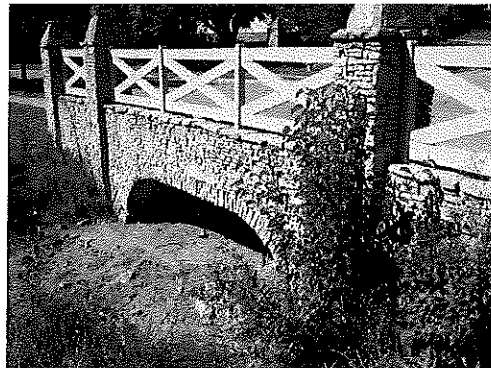
The Olde Mill Bridge is comprised of two identical structures. Each structure has four stacked stone pillars approximately 12' high with an 8' high stacked stone wall 33' in length. Additionally there is a wooden fence 3' high by 33' in length. This reserve funds the eventual replacement of the structure.

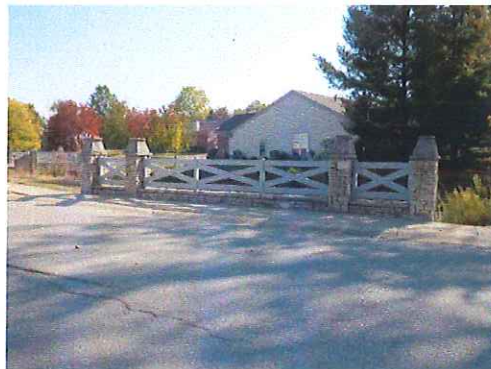
The Olde Mill Bridge is comprised of two identical structures. Each structure has four stacked stone pillars approximately 12' high with an 8' high stacked stone wall 33' in length. Additionally there is a wooden fence 3' high by 33' in length. This reserve funds periodic repairs to the structure.

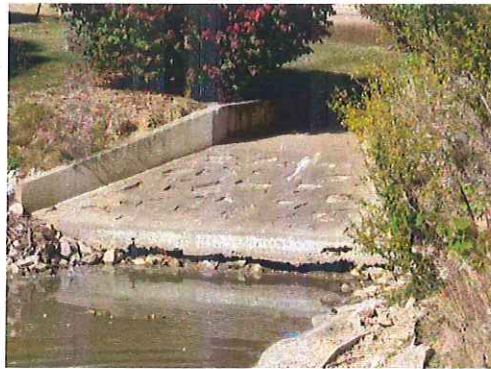
The wier that provides for flow from Pond 6 to Pond 7 has a concrete spillway and concrete sides approximately 3' high. The lifespan of the wier is indeterminate and is likely not to be replaced. We are allocating \$3,000 every 7 years for any concrete repair that would be needed.

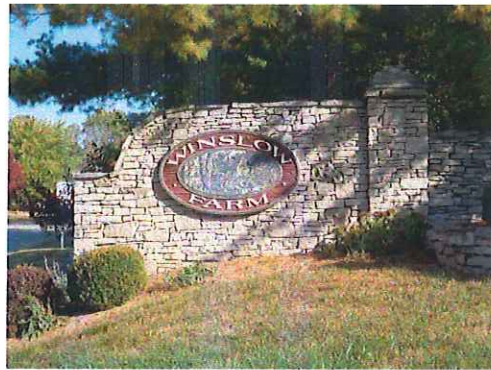
The Winslow Road Entrance has a stacked stone fence with limestone cap that has an average height of 3' and runs for 292' along Winslow Road.

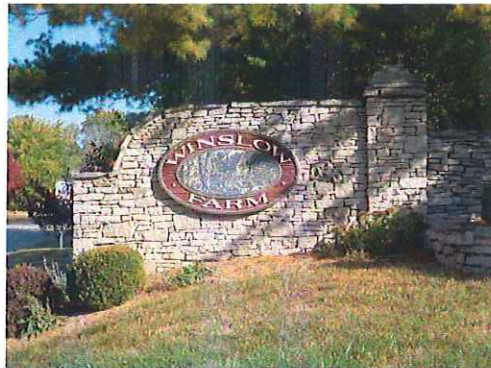
The Winslow Road Entrance has a stacked stone fence with limestone cap that forms a planting bed.

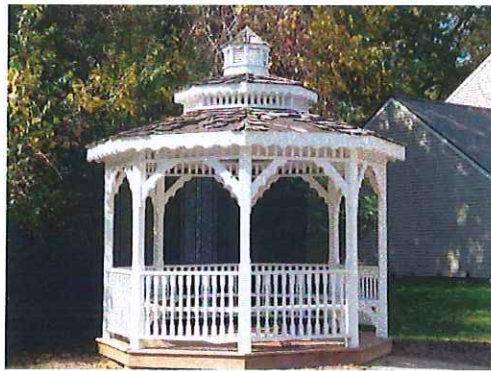
The gazebo is an octagon shaped white wood structure on a 10' diameter concrete slab. There are benches on seven of the sides with decorative wood throughout. The roof is asphalt shingled and supported by eight posts. This reserve funds the periodic refurbishment of the asset including painting, re-roofing and repairs.

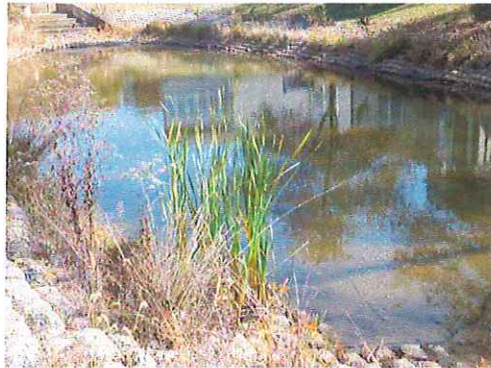
Pond dredging cost estimates and schedules have been provided by the client and are based on the 2019 WFCA Pond Committee Report (10/22/2019). The client has informed us that all ponds will need to be placed on a 7-year cycle of dredging.

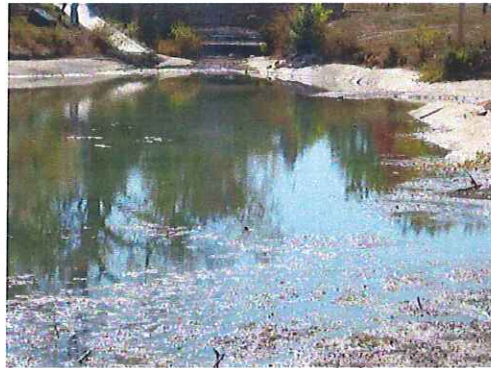
Pond dredging cost estimates and schedules have been provided by the client and are based on the 2019 WFCFA Pond Committee Report (10/22/2019). The client has informed us that all ponds will need to be placed on a 7-year cycle of dredging.

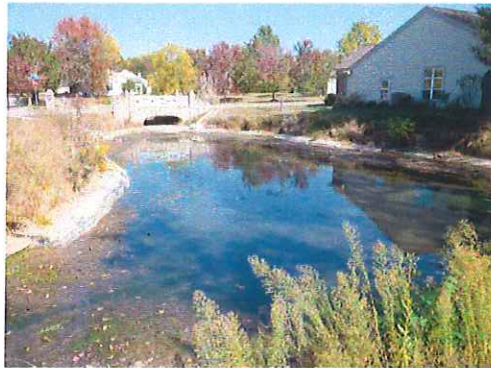
Pond #5 is approximately 4,587 SqFt in area with 267 LnFt of shoreline. Going forward, we have proposed an allowance of \$5,000 every five years for pond repair and maintenance.

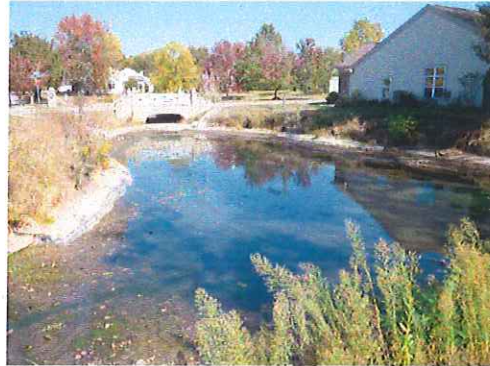
Pond dredging cost estimates and schedules have been provided by the client and are based on the 2019 WFCFA Pond Committee Report (10/22/2019). The client has informed us that all ponds will need to be placed on a 7-year cycle of dredging.

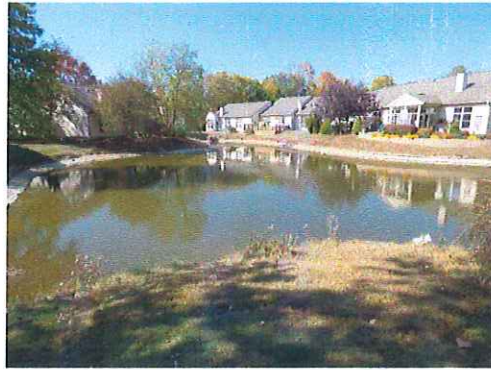
Pond #6 is approximately 14,115 SqFt in area with 645 LnFt of shoreline. Going forward, we have proposed an allowance of \$5,000 every five years for pond repair and maintenance

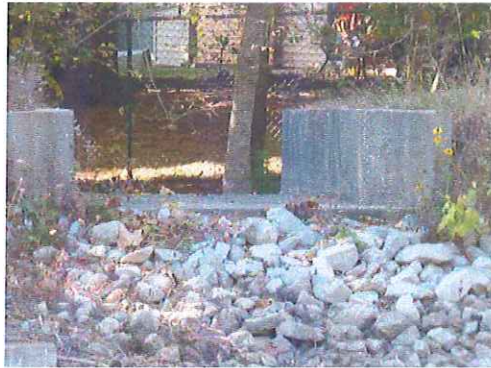
There is a concrete spillway at the outflow of Pond #7.

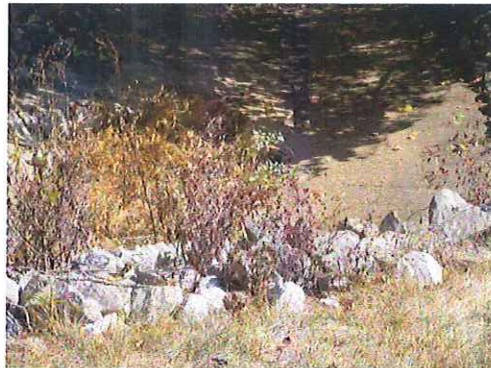
The dry pond should require little expenditure. Occasional rip rap or maintenance can come from the annual operating account.
