Pond #3 - North West Arm
 Added ROCKS in Green Ink due to reinforcing needed for flooding

Water-Garden plus Sediment Pit at Bridge Inlet to Pond Three

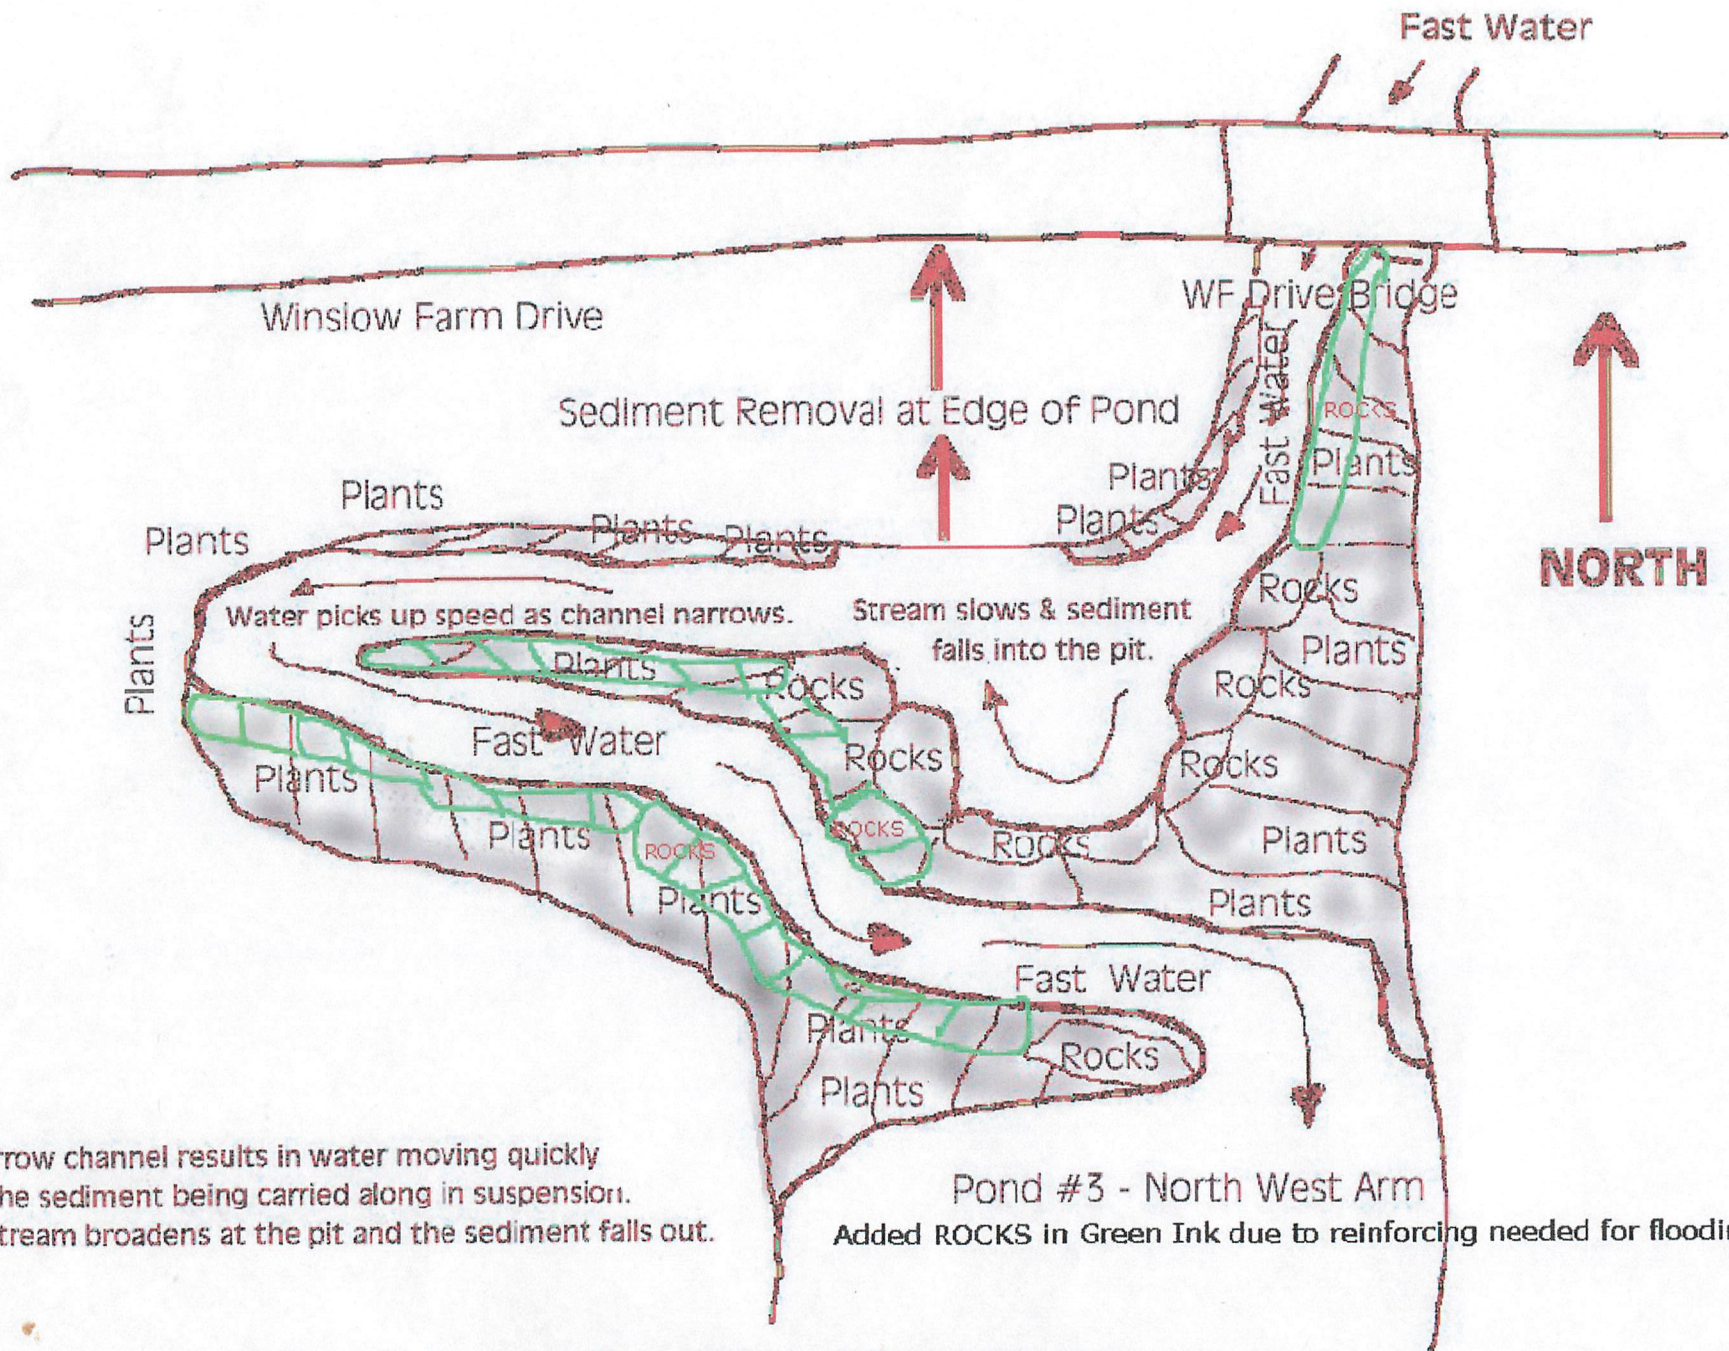
A narrow channel results in water moving quickly and the sediment being carried along in suspension. The stream broadens at the pit and the sediment falls out.
